International Boundary Commission,
United States and Canada

Joint Annual Report

2017

Maintaining a Peaceful Boundary for more than a Century

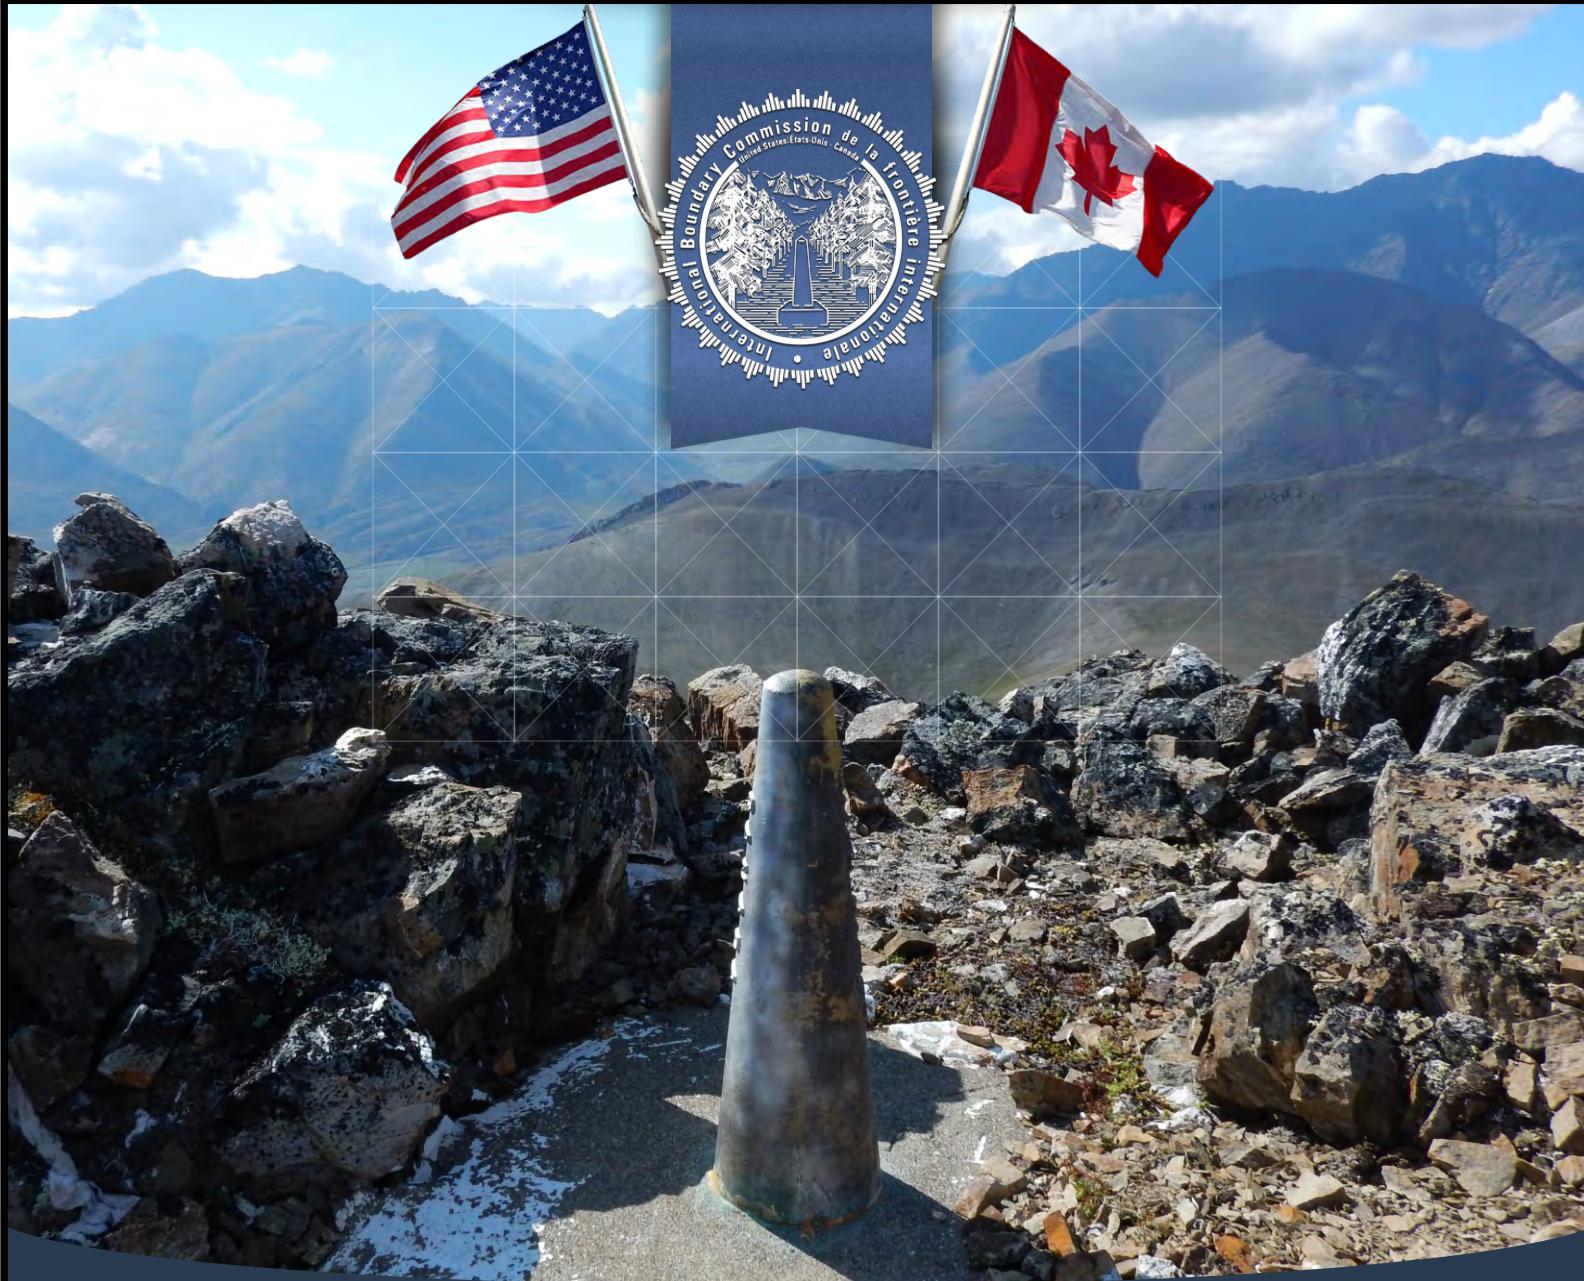
Photo de couverture

La photo de couverture montre la vue vers le sud à partir de la borne 9 sur le 141e méridien (Yukon/Alaska). La borne 9 est située environ à 298 km au nord du cercle polaire arctique et 42 km au sud de la mer de Beaufort.

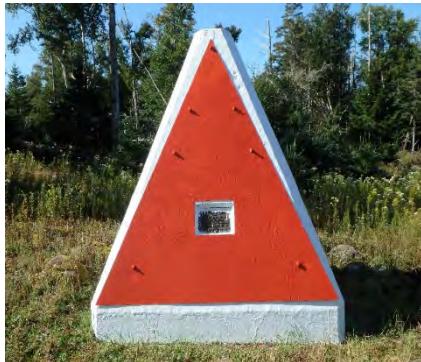
Figure 1: A Range Mark on
Passamaquoddy Bay

The Passamaquoddy Bay section of the international boundary is delimited by turning points tied to a series of Range Marks. These are large, brightly painted monuments on shore that come in pairs. This year's contract was to clear the bush in front of the markers and to repaint the markers to ensure that they were easily visible from the water. An inspection after the work was completed showed this section of the boundary to be in very good condition.

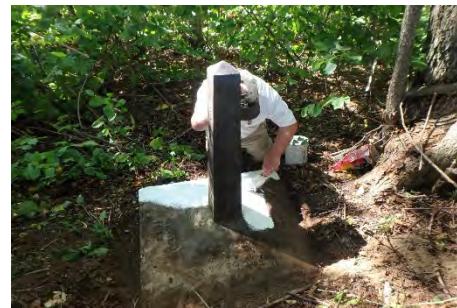
Figure 2: Cleaning and painting a Reference Monument

This project continues the work done last year along the St. Francis River. This year the Reference Monuments along the St. John River were located, painted and repaired. When repairs were required the crew used traditional survey methods to ensure the Reference Monuments were rebuilt in their original locations thus ensuring the integrity of the boundary which runs down the St. John River.

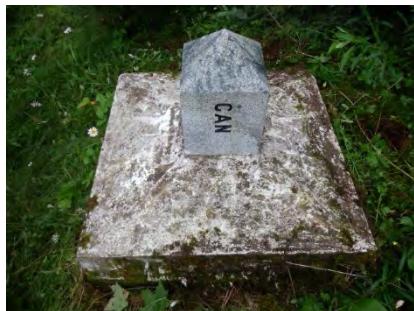
Figure 3 - Reference monument 63-00 as found during the survey

This project completes the resurveying and spatial reference update of the Southwest Branch of the St. John River. In this project, the final three Reference Monuments that define this section of the boundary were geolocated with a high precision GPS survey and tied into the NAD83 datum. These three monuments had either been destroyed and subsequently replaced, or there was insufficient survey information collected previously to determine their coordinates on the NAD83 datum.

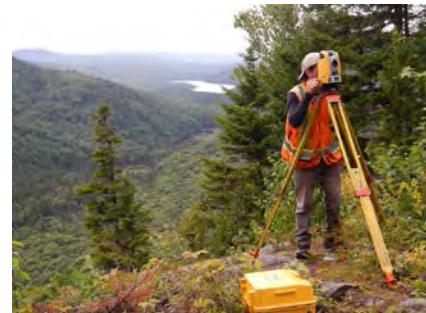
Figure 4: Doing survey observation with total station.

This is one of a series of GPS and conventional survey projects that, when completed, will support further boundary monuments maintenance and produce a high accuracy coordinate definition on the NAD83 datum for this section. For surveying purposes, the section has been broken down into 95 separate traverses, all of which have been surveyed by conventional and/or GPS methods. The goal of this project was to improve the monument position accuracy to up to 1:100,000 (less than 1 cm error in 1 km of measurement) when analyzed; the new observations are much more accurate and well within modern standards. Survey work will continue in this section next field season.

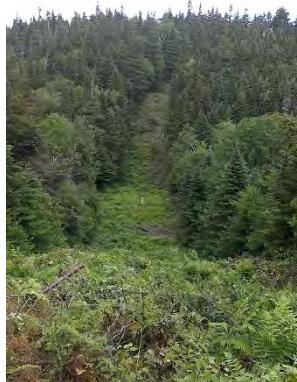
Figure 5 - View of the vista after clearing operations.

69.3 km (43.4 miles) of vista between monuments 405 and 452 were cleared by contract. During the inspection of the work, the IBC inspected 73 monuments. The ongoing efforts over the last years have led to a well-defined open vista from the beginning to the end of this difficult section. Vista clearing work will continue on this section in 2018.

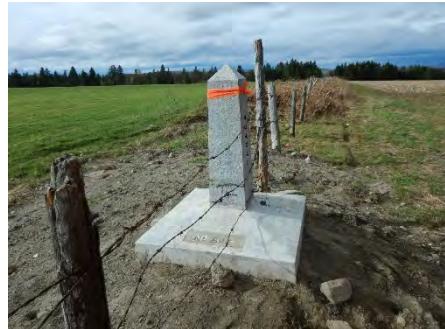
Figure 7 - Monument 545 after restoration

Starting in mid-May a crew of two IBC employees inspected, painted, and where necessary conducted local surveys for the 243 monuments that mark the eastern half of the West Line section of the boundary (Monuments 518 to 631). 84% of these monuments were found to be in fair to good condition. Subsequent to the initial inspection tour, a larger crew retraced their steps with the materials and machines required to repair five existing monuments and install two new monuments that were required to mark the boundary in an area adjacent to a popular snow machine trail.

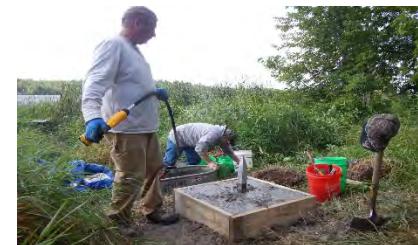
Figure 9 - Restoration of RM 17

Another team inspected and repaired Reference Monuments in this section. The region presents the same logistical challenges as the previous section because it is a water boundary running through the Rainy River and Lake of the Woods. 53 monuments were refurbished.

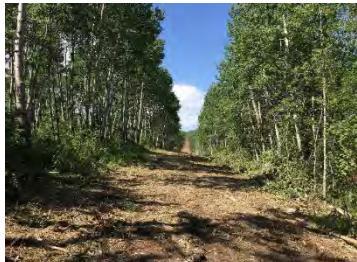
Figure 10 - View of the vista after clearing operations

This has been a traditionally difficult section of the boundary to access for vista clearing. An opportunity arose this year and an IBC crew was diverted from their planned survey project in the area to instead clear what had become mature growth on the vista. Specialized equipment was used to clear the growth and the boundary in this section is now in good condition.

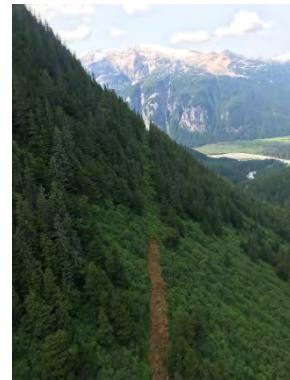
Figure 11 - View of the vista in Southeast Alaska

Also known as the Alaska Panhandle, this is one of the most rugged sections of the boundary. The boundary itself runs along the crest of the Boundary Range of the Cascade Mountains. Bad weather in S.E. Alaska brought this project to a virtual halt. Only 10% of the vista was cleared this year. This project will roll over into 2018 and the clearing will continue.

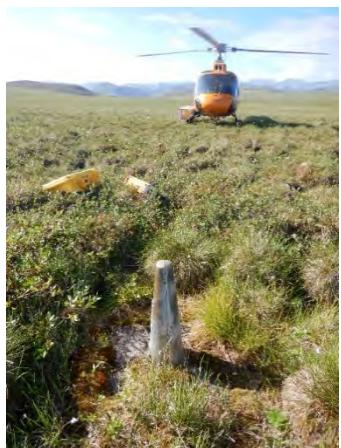
This is the last in a series of projects to resurvey the 141st Meridian section of the boundary. The results of these surveys will be analyzed and adjusted to produce a new coordinate definition of the boundary on the modern NAD83 datum.

This particular project extended from the shore of the Arctic Ocean at Monument 0 to Monument 80, 400 km (250 miles) inland. In that distance the boundary covers coastal plains, high plateaus, mountain ranges, permafrost and, this year, several active forest fires. There are few roads in this area and all transportation to the boundary was by helicopter. This precluded any monument maintenance beyond applying a coat of paint to the monuments.

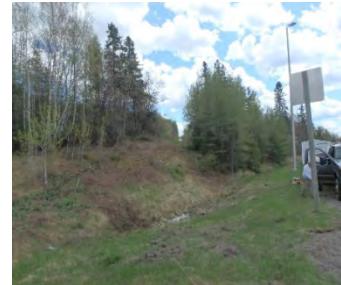
With the objective of improving visibility of the boundary at port of entries, monuments in the vicinity of the Houlton/Woodstock port of entry were inspected and re-furbished. A total of four (4) monuments were cleaned and painted. Upon request of US Border Patrol, a short portion of the vista was cleared of overhanging branches though it had not been too long ago the area had been cut.

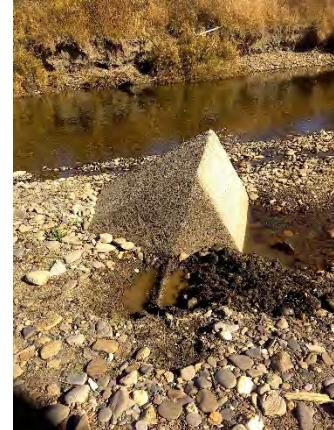
In 2007 and 2008, the IBC launched two prototype projects to monument what were formerly mid-stream Turning Points (TP) defining the international boundary along Halls Stream and the St. Francis River. Many of the mid-stream turning points along Halls Stream are now located on dry land due to the meandering of Halls Stream over the years. While the northern portion of Halls Stream runs over bedrock and its course is relatively stable, the southern portion of Halls Stream runs over alluvial soil and its course can change radically from year-to-year and over the course of decades. In some cases the TPs are now located in the middle of farmers' fields. Without some form of demarcation, the location of the international boundary would be virtually impossible to discern.

This year's monument inspection project was undertaken to document the results of this demarcation 10 years after the monuments were installed. Several of the installed monuments fell victim to further meandering of the stream (see photo above) and others were buried under several feet of gravel and were ineffective in marking the boundary. The Commissioners are currently debating best way to effectively demarcate this type of boundary section.

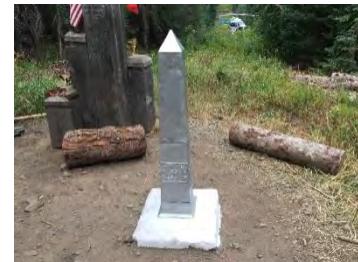
Monument 78 on the 49th parallel had been reported by a Forestry Department employee as being in poor condition. A crew from the US section rebuilt the monument on its existing base. This monument is at the head of a popular hiking trail and seems to be a popular destination and camping site.

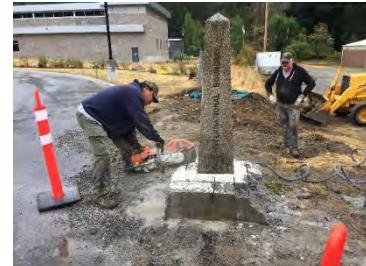
The supervisor at the POE requested that Monument 216C be moved from its current location to somewhere out of the line of traffic. The crew removed the current monument and created a new base some distance away where there is no traffic but the monument is still highly visible. A new monument will be installed on the base in the near future.

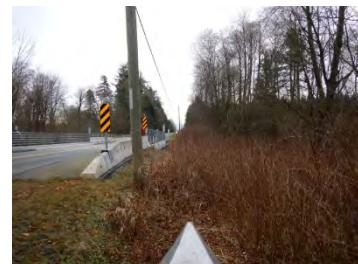
As part of the IBC's mandate to maintain a clear vista along the Canada/U.S. boundary, we have been in contact with B.C. Hydro since the 1960s regarding a line of hydro poles along 0 Avenue in the Fraser valley. While the poles do not interfere with IBC clearing operations in the area, the poles do increase the cost and complexity of maintaining the boundary in this area. We have a long term understanding with B.C. Hydro that these poles will be moved away from the vista as normal maintenance and upgrade activities take place. This survey was done in support of these efforts and will serve as the basis of further discussions with B.C. Hydro.

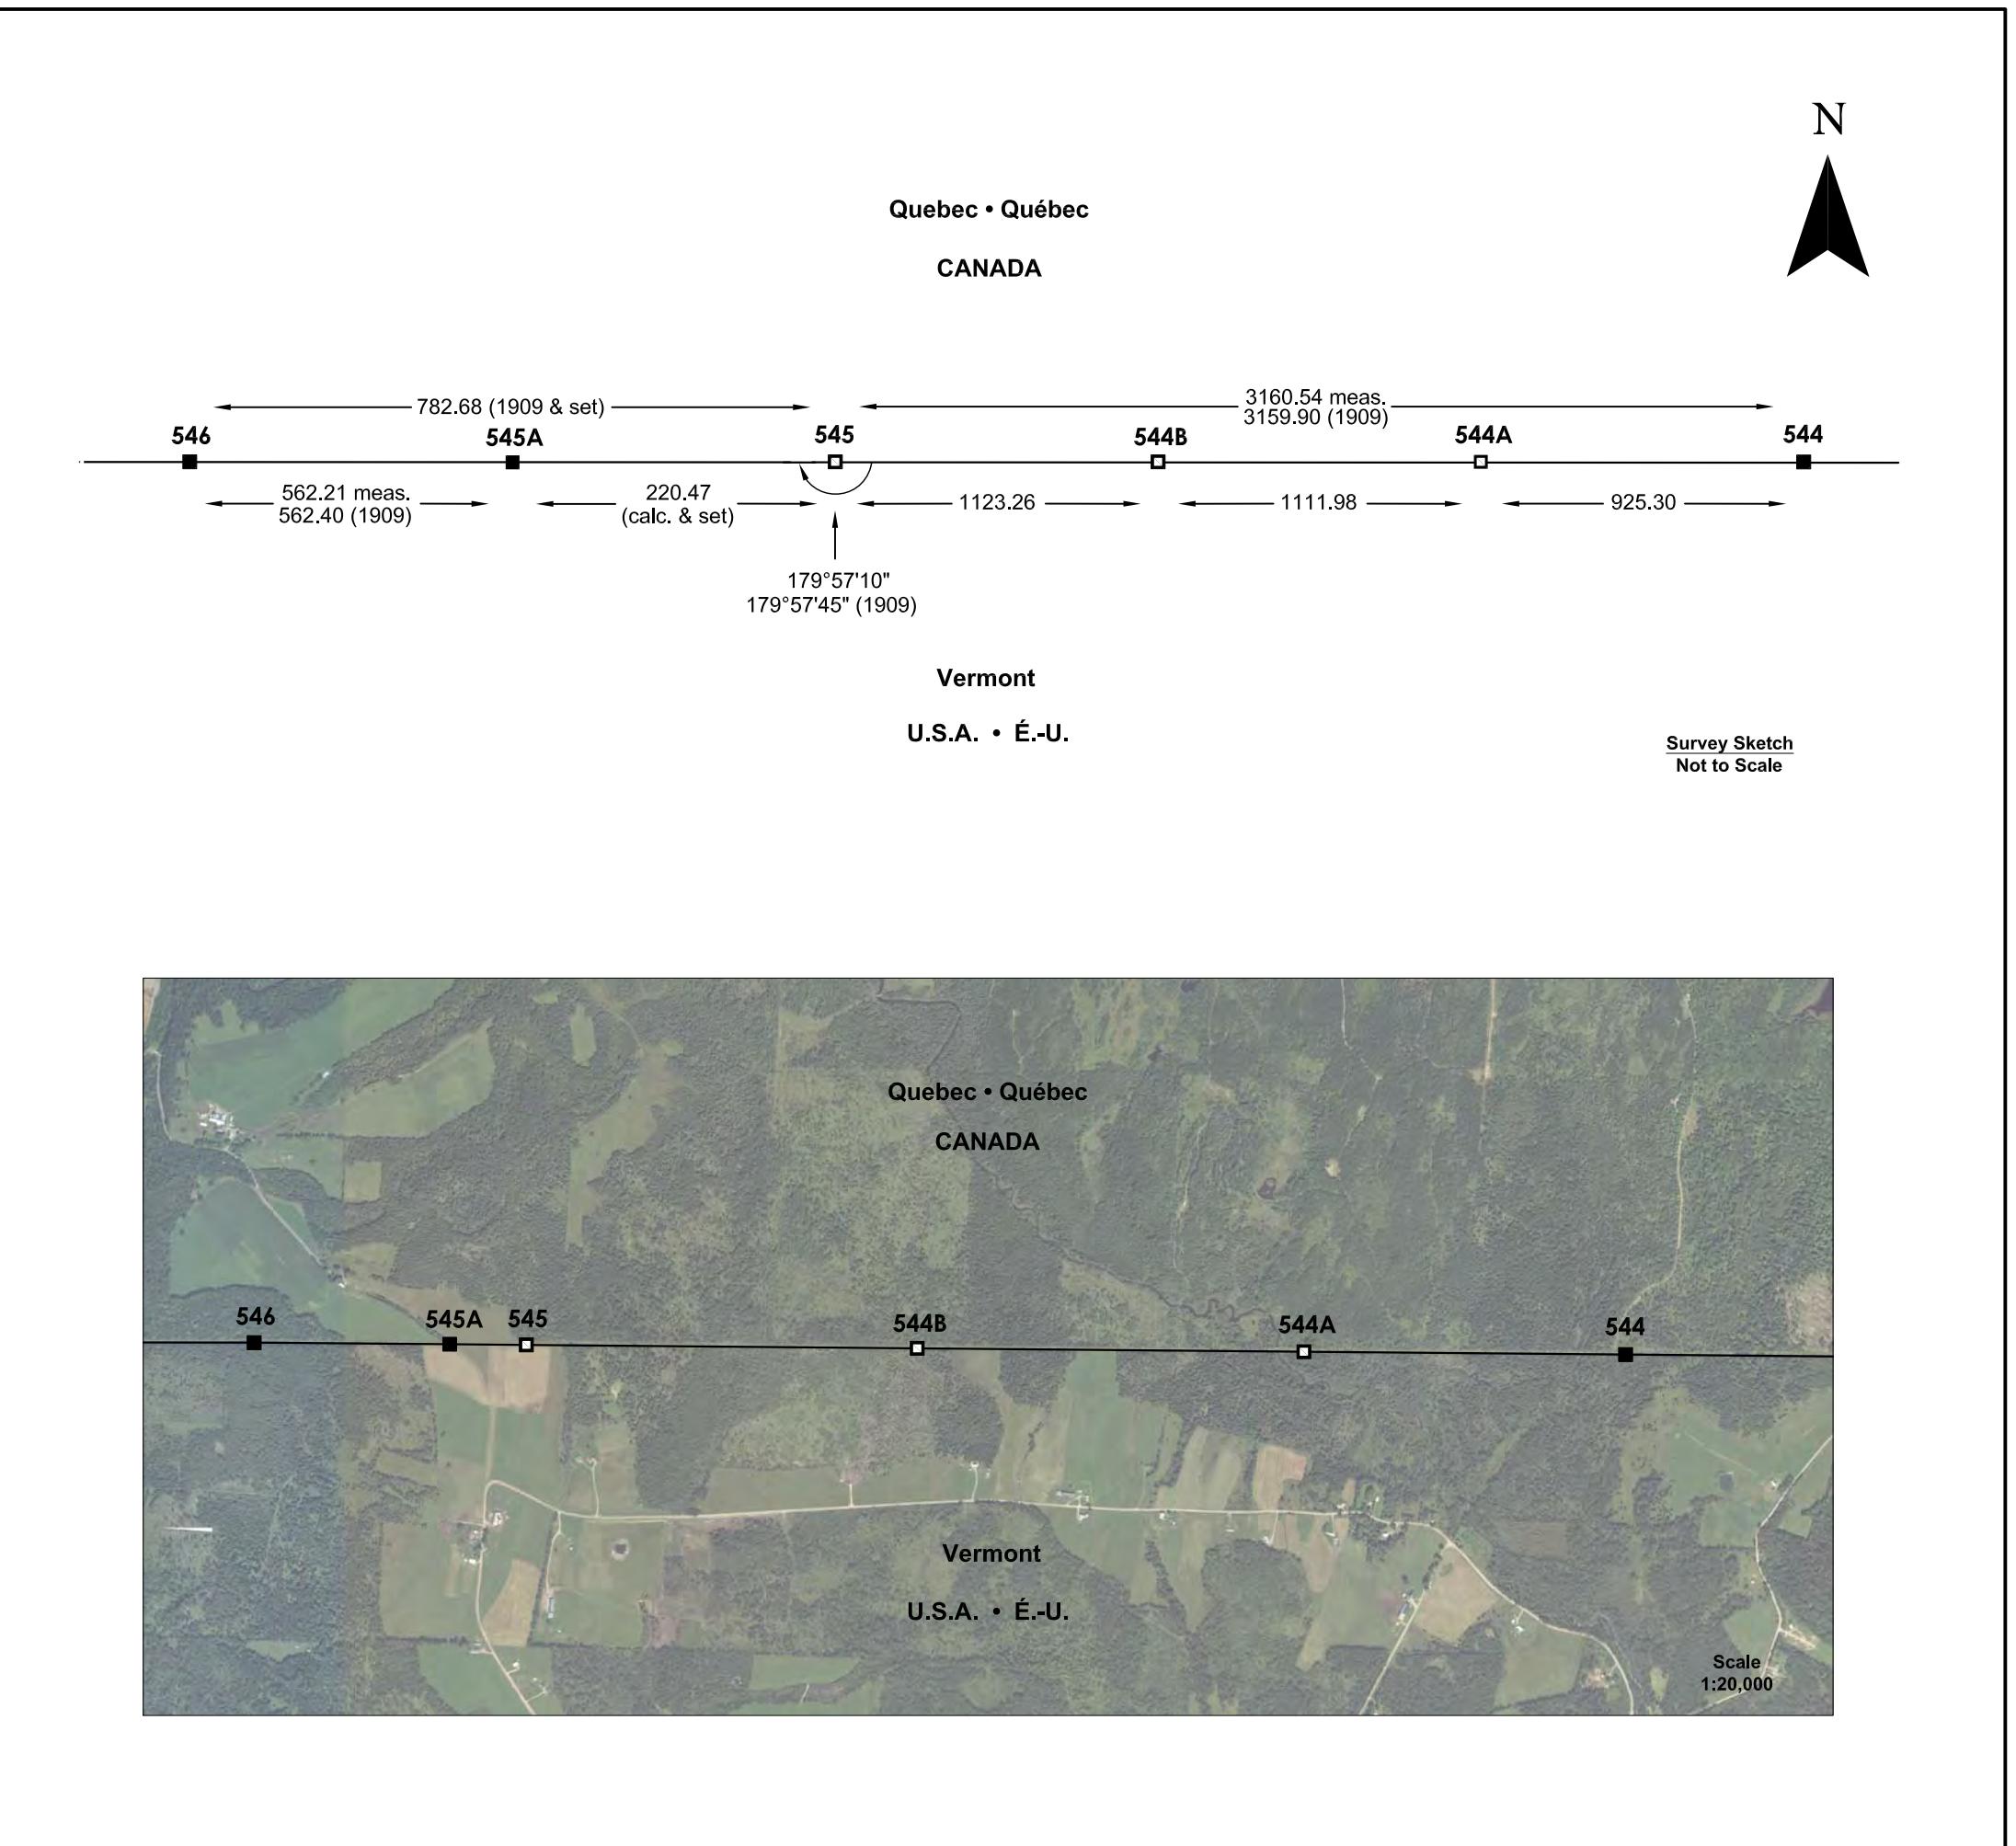
MON 545, 544A & 544B

BOUNDARY MONUMENT ESTABLISHED
BORNE FRONTIÈRE POSÉE
